AEFA Project No. 88-06

# ARTIFICIAL AND NATURAL ICING TESTS OF THE EH-60A QUICK FIX HELICOPTER

June 1988

Final Report

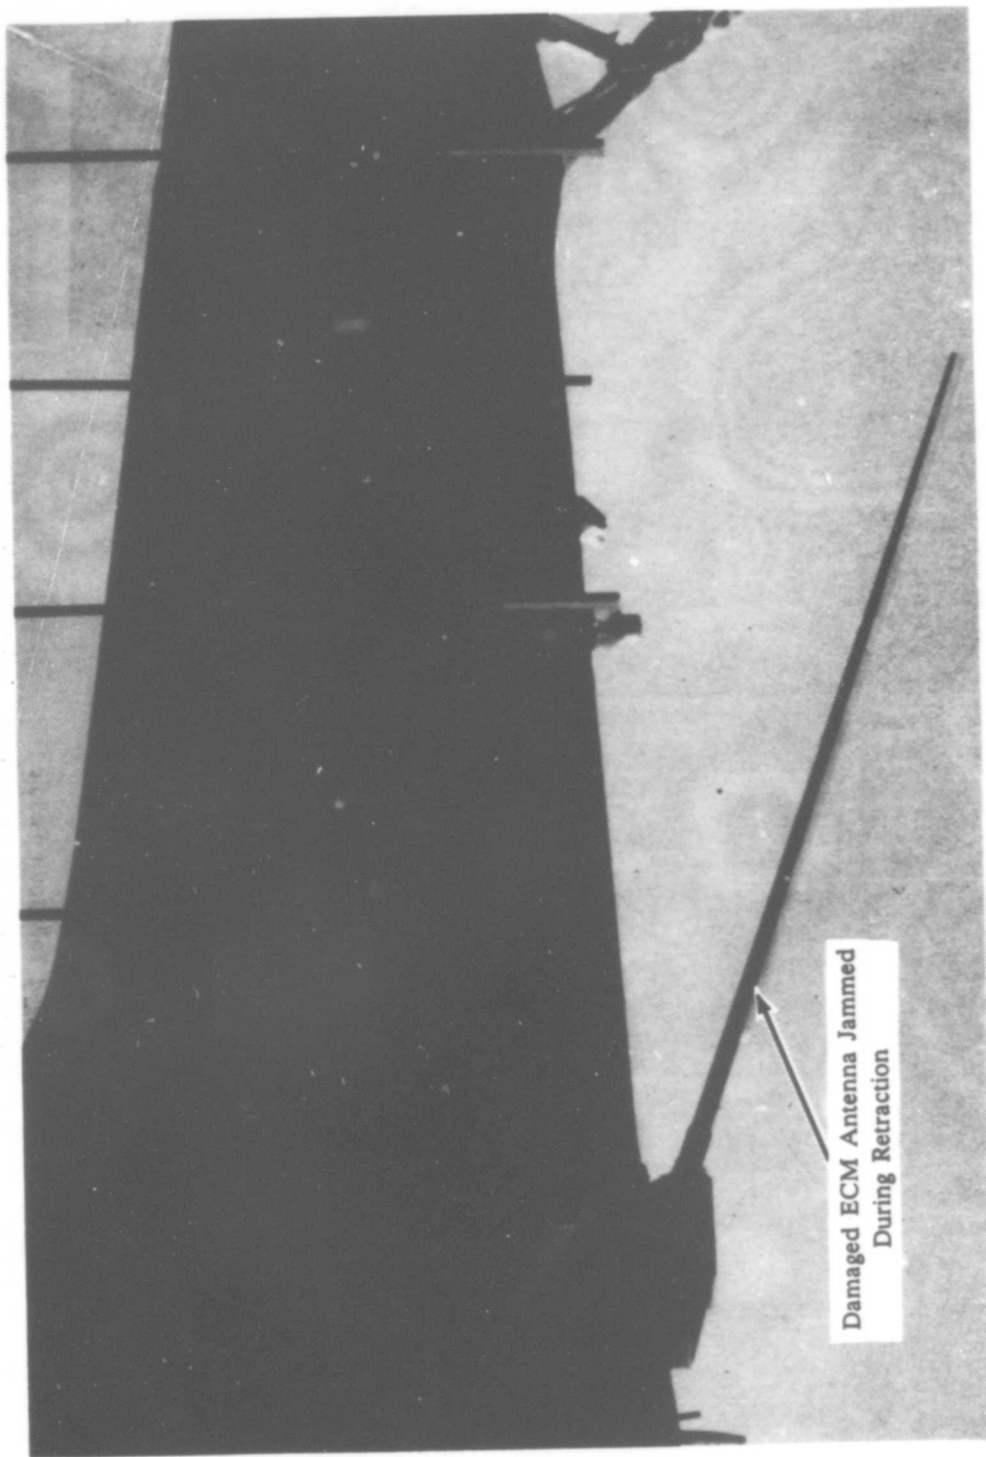
23. Following a natural icing flight of 1.5 hours duration at  $-9.3^{\circ}\text{C}$  with a LWC of  $0.2 \text{ gm/m}^3$ , the ECM antenna failed to fully retract to the stowed position (fig. H-20). The aircraft was brought to a hover and the ECM antenna removed from the antenna mount. Post flight inspection revealed the right pivot stud on the antenna mount had sheared (fig. H-21). The sheared pivot stud permitted the antenna mount to skew in the housing during retraction resulting in the antenna mount being jammed against the housing. The left pivot stud was bent and the actuator connecting point to the stud arm subassembly would not rotate due to torsion damage (fig. H-22). The ECM antenna was removed for the remainder of the tests. The TIR submitted by AEFA is presented in

appendix G. The damage to the pivot stud of the ECM antenna mount following an icing encounter, preventing full retraction of the ECM antenna, is a shortcoming.

Figure H-20. Jammed ECM Antenna  
Natural Icing - .20 gm/m<sup>3</sup> LWC, -9.3°C OAT, 92 min

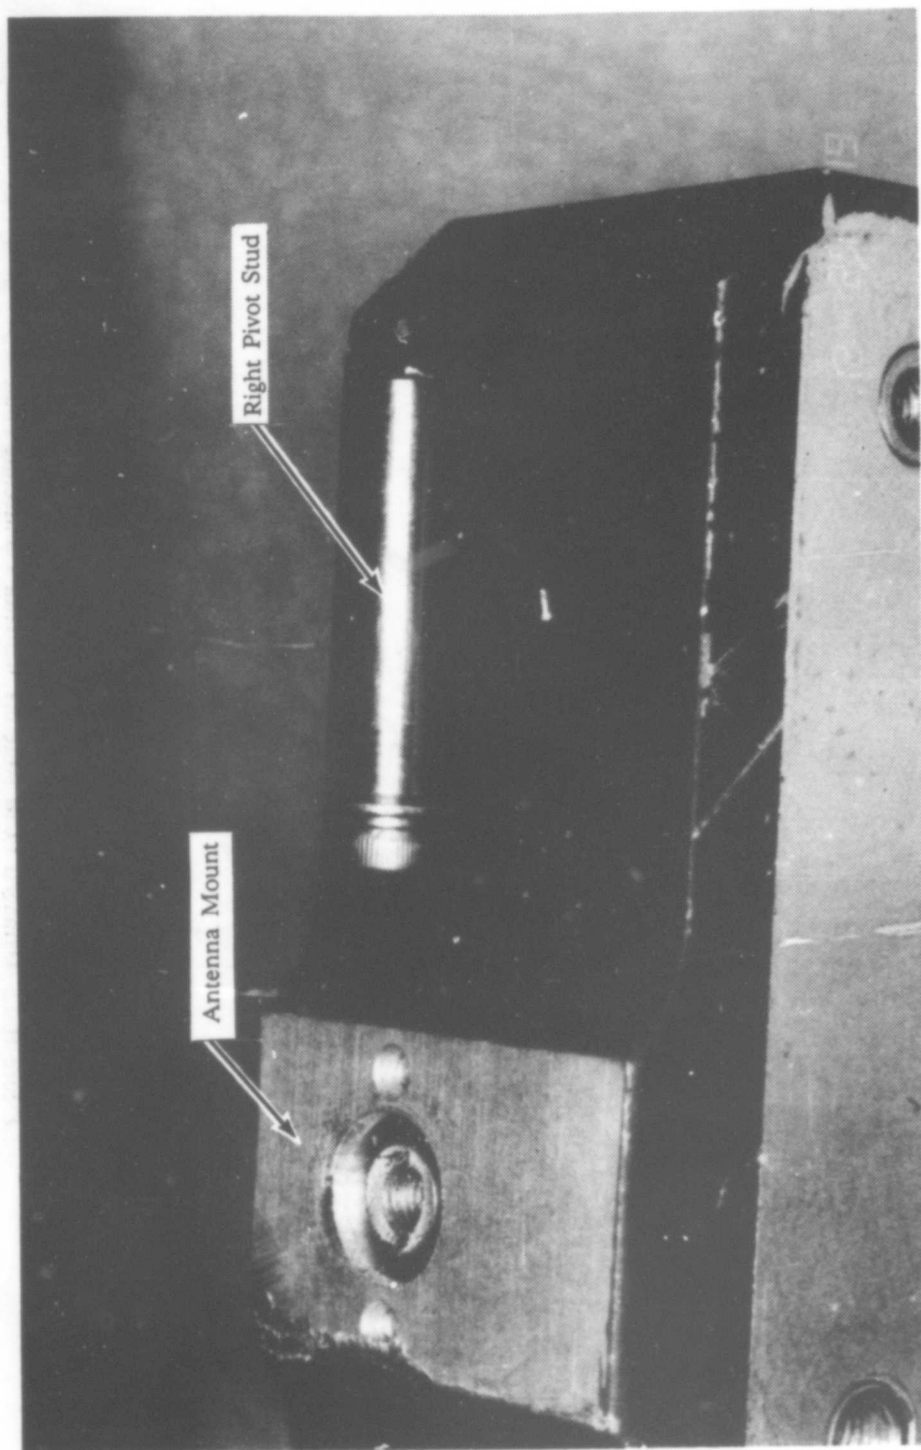
Figure H-21. ECM Antenna Mount and Sheared Pivot Stud  
Natural Icing - .20 gm/m<sup>3</sup> LWC, -9.3°C OAT, 92 min

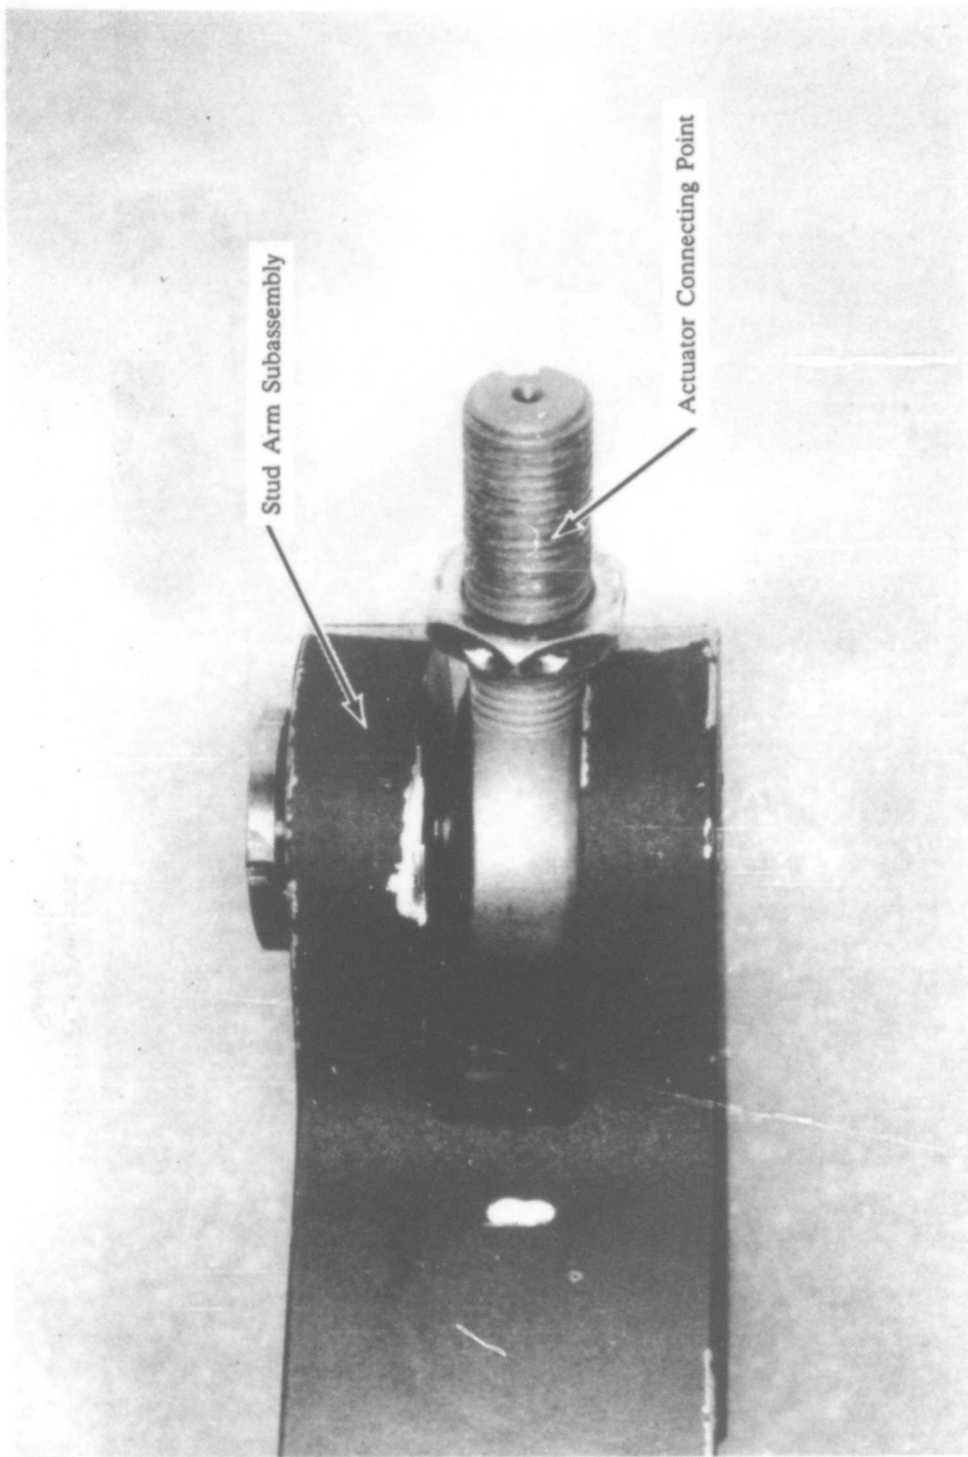
Figure H-22. Damaged ECM Antenna Actuator Connecting Point  
Natural Icing - .20 gm/m<sup>3</sup> LWC, -9.3°C OAT, 92 min
